Postmortem on an Oil Pressure Switch

Bill Noble, Santa Monica, CA

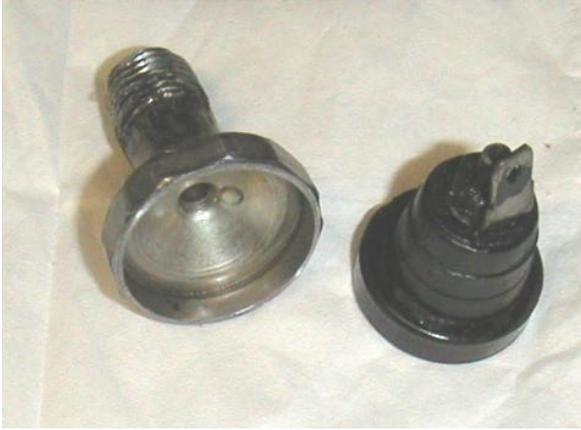
But now we come to the crux of this article: Why did the switch fail? For that we have to take it apart. Figure 2 shows the two outer parts of the switch – a bakelite top part housing a terminal, and a metal bottom part that screws into the engine block. The bakelite top is cracked (which you cannot see in the picture) – but when I started to remove the part it was all together.

Figure 2 - The exterior parts of the switch

So, this is a cheap part, and it's easy to change. And, this “post mortem” shows you why, even if the pressure switch on your engine is not broken when you work on the engine, it's still worthwhile to change it – after 40 to 50 years the diaphragm material will be near to failure, or will already have failed – a few dollars spent changing the switch will save you a lot of hassle later and will help keep your hands clean when you want them to be.

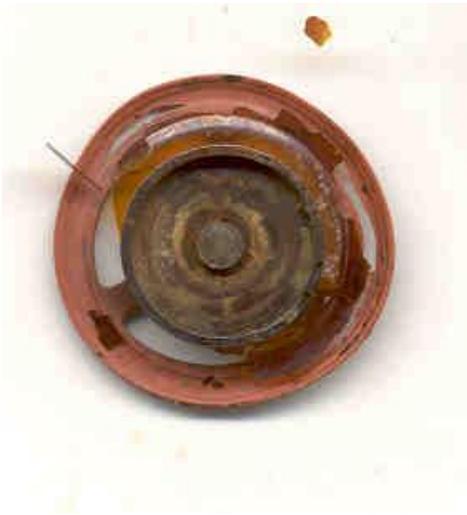
Inside is a diaphragm assembly (figures 3 and 4), which as you can see is in rather sad shape. Not shown is a spring that rides on top of the metal part in the diaphragm assembly and contacts the post at the top of the bakelite housing – that part disappeared when I removed the switch, but you can imagine it easily enough.

Looking at Figures 3 and 4, you can see that the diaphragm assembly consists of four separate parts:

1. a red colored rubber seal, with webs that connect it to the other parts for ease of assembly
2. a copper upper cup on which the spring rests
3. a steel lower cup that contacts the steel body when oil pressure is low
4. a very thin (and now very brittle) plastic diaphragm – you can see pieces of it in figure 4 sticking out from the assembly.

Figure 3 Diaphragm assembly – top (no oil) side

So, what happened? It is not clear whether the upper housing developed a small crack, or whether the diaphragm failed allowing oil into the upper part of the housing that then caused a crack – I suspect that there may have been a crack in the housing for many years, and that the diaphragm then failed allowing oil to leak through the crack and also causing the crack to expand, leading to catastrophic failure.

The diaphragm was (is) in fact so brittle that it's like old cellophane tape – in fact it may have been cellophane, I can't be sure. What is important is that the other materials will last a very long time and won't by themselves deteriorate and lead to failure. Even a hairline crack in the Bakelite top part would be benign (unless the top separated from the bottom). But the diaphragm has become brittle and will fail due to normal flexing.

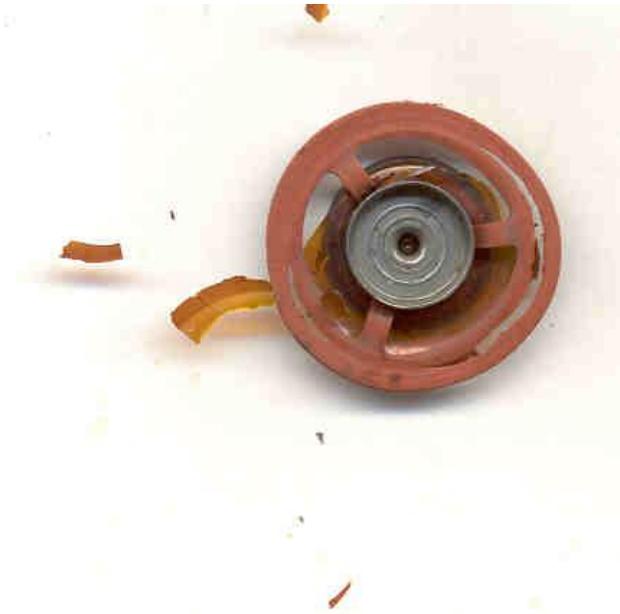
Figure 4 Diaphragm assembly, bottom (oil) side
